A bad seal wire may consist of the following.

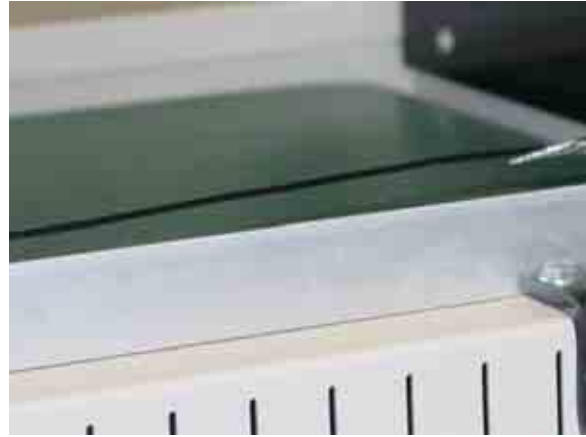
Burnt Teflon coating or pitting of the wire.
